October 22, 2018

Re: Cobourg East Pier Investigation
Our File: 18-2775

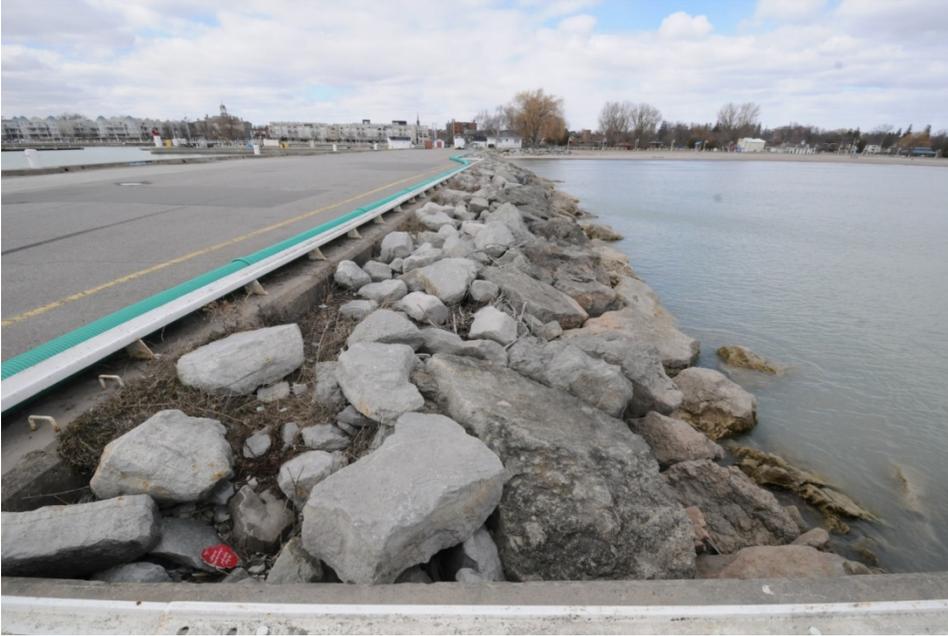
Stones along the revetment were found to be placed in a random fashion with small gaps between them as seen in Photo 1. The lake bottom composition was observed as mostly sand material. There was no evidence of movement in the revetment stones, no missing stones or evidence of material spilling out from behind the revetment.

Photo 1 - Revetment East Side

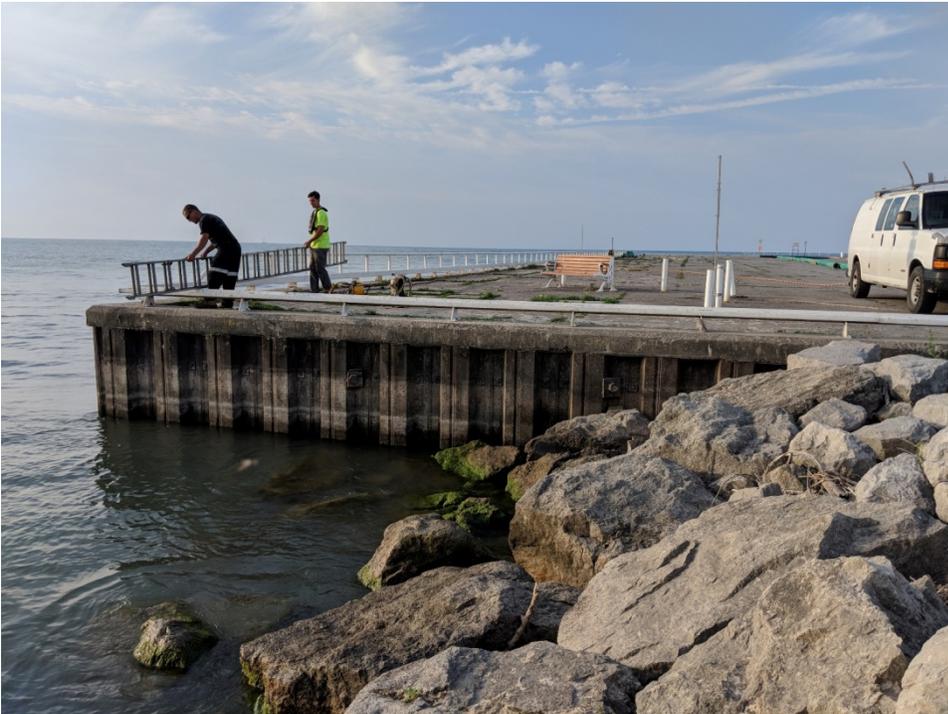
A steel sheet pile wall starts at the south end of the revetment (Photo 2). This point was marked as chainage 0+000m. The next corner to the east was noted at 0+015m. Water depth at the corner at station 0+015 was approximately 1.0m on the day of inspection. Stones extending from the revetment against this wall do not continue around the corner.

Photo 2 - East Side Steel Sheetpile Wall

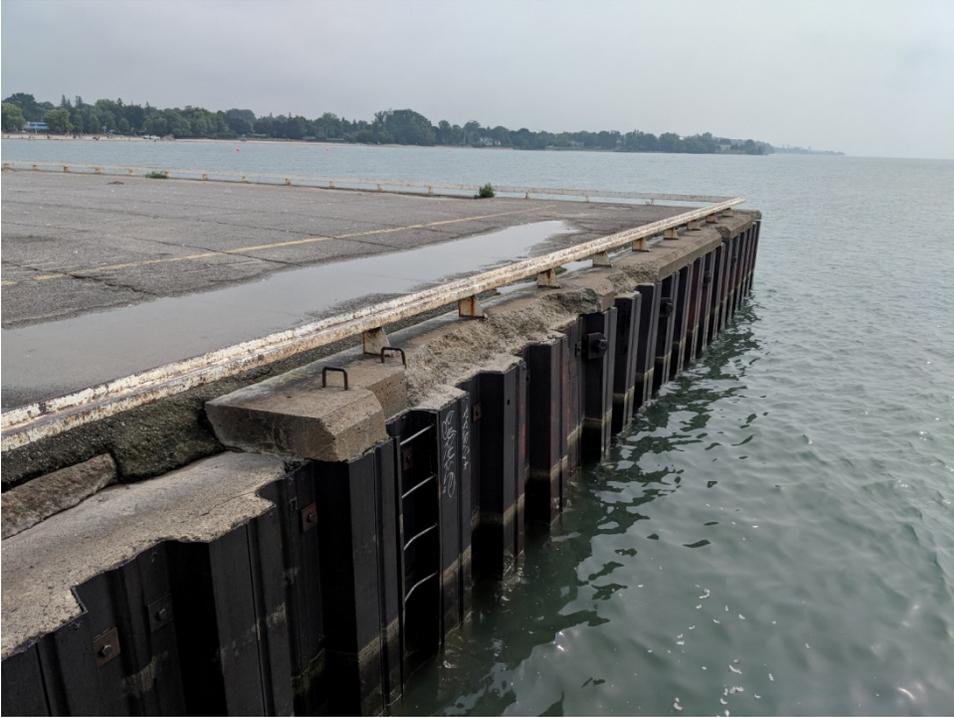
From 0+000 continuing south the steel sheet pile wall is composed of z-piles. The steel sheet pile wall includes a shallow concrete cap from chainage 0+000 to 0+150 which is approximately 30 cm high. Between chainage 0+150 and 0+163 the concrete cap has sections missing in it (Photo 3). At chainage 0+163 there is a 90 degree corner and the sheet piles that continue south no longer have a cap (Photo 4). The deck is also 0.5m lower after 0+163m.

Photo 3 - Deteriorated Concrete Cap Chainage 0+150

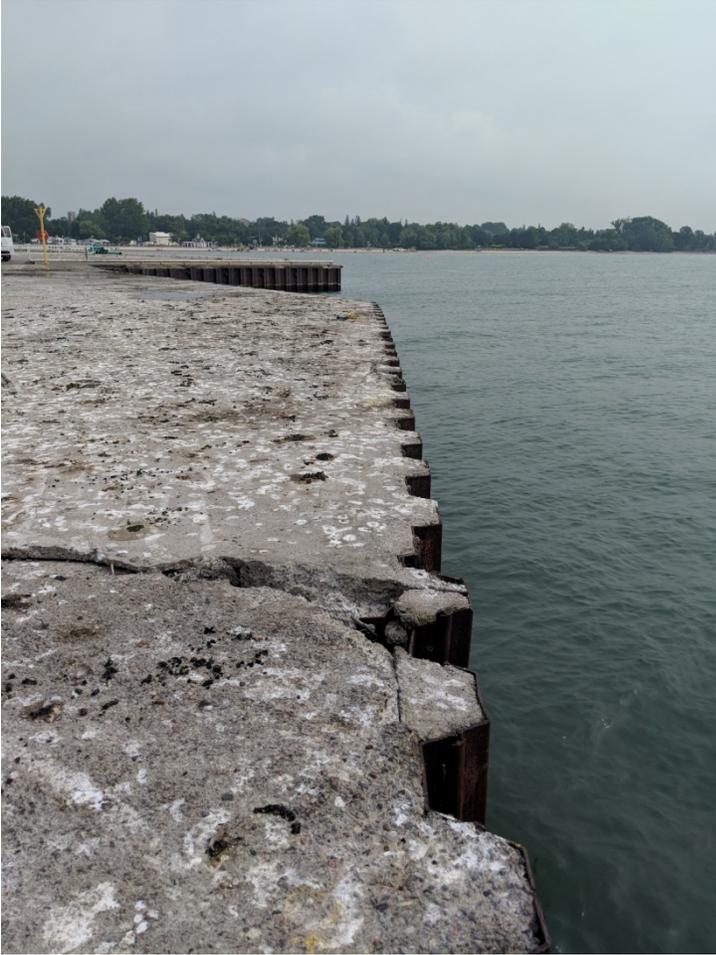
Photo 4 - South End Sheetpiles Without Concrete Cap

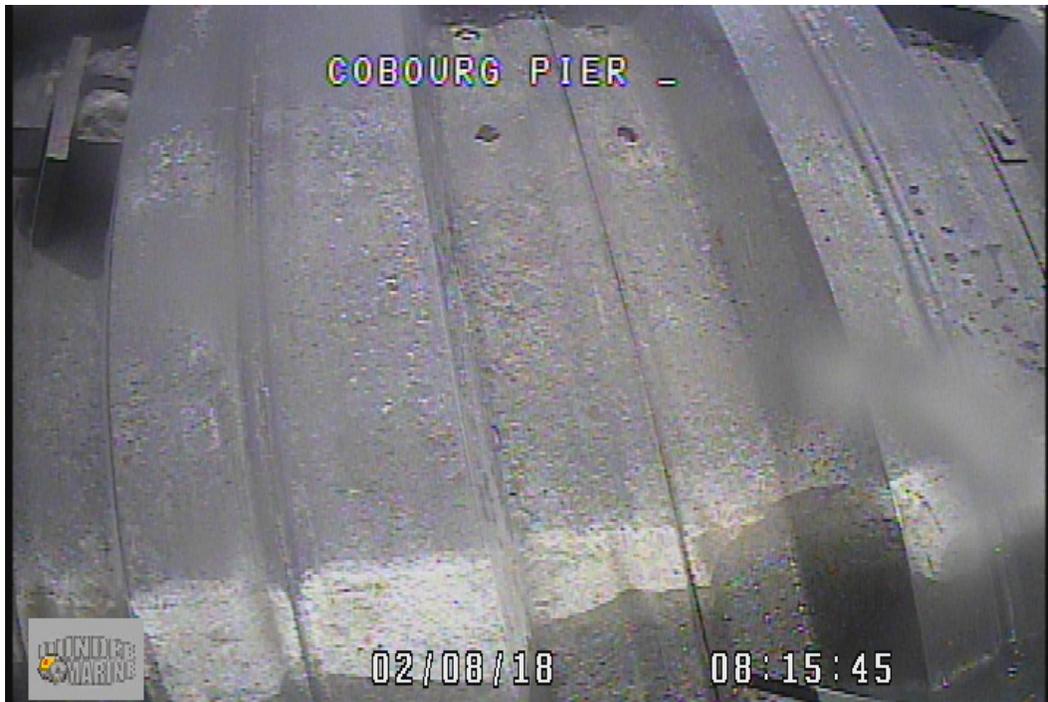
Wale bolts were located approximately 1m above the water level on the day of the dive inspection which puts them at an elevation of approximately 76m IGLD85. A few bolts were found to be missing along the length of the wall (Photo 5).

Photo 5 - Tie Rod Bolts Missing East Wall

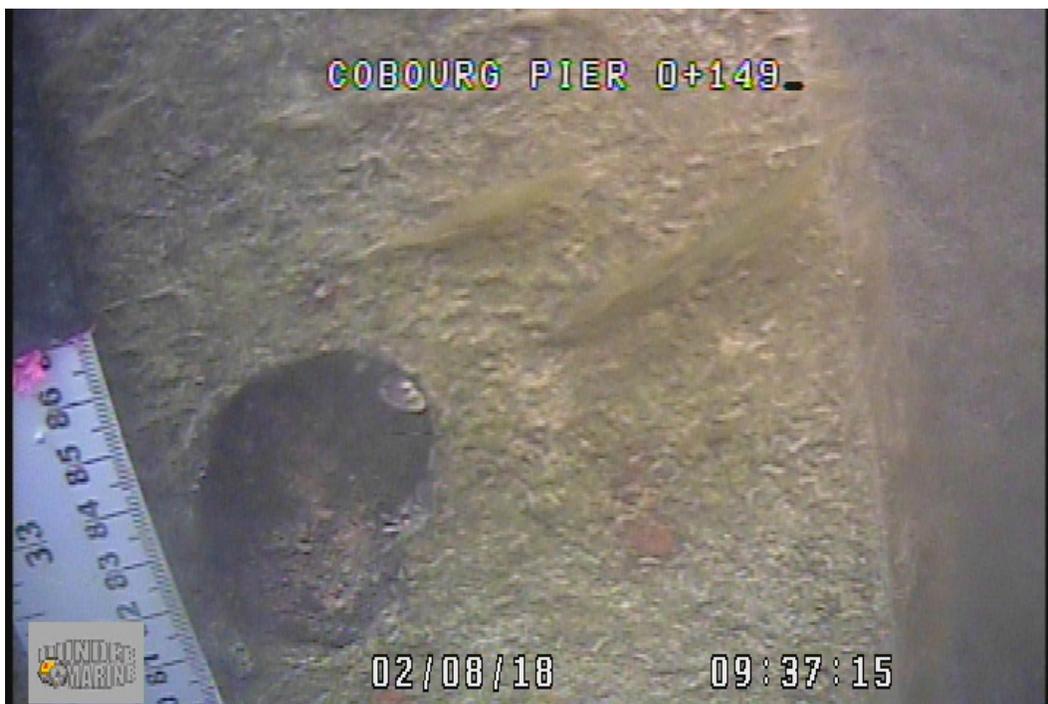
At approximately chainage 0+60m, water was seen running in and out of a small hole approximately 5cm in diameter that had been cut in the wall at water level. Rock backfill material could be seen behind the wall and there was no evidence of loss of fill material. Other similar sized holes (Photo 6) were found at chainages 0+061m, 0+098 (2 holes), 0+100m, 0+118m (above water level), 0+150 and 0+180m (above water level).

Photo 6 - Cut Hole in East Wall

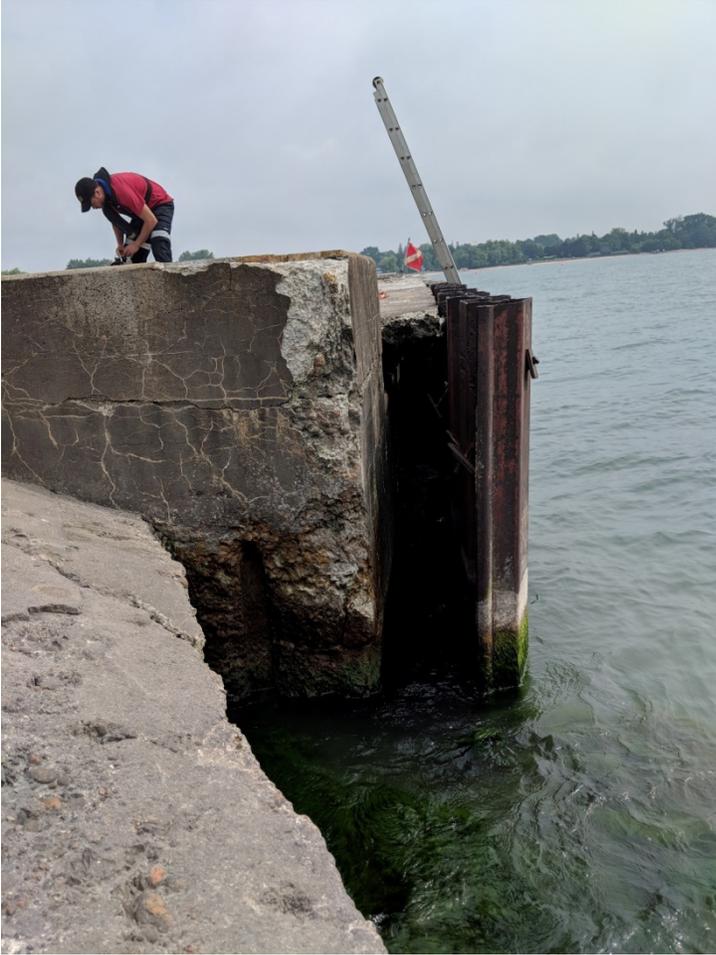
The sheet pile wall turns west at 0+191m at a 45 degree angle and the z-piles change to u-piles. On the day of inspection the water depth at this location was approximately 3.0m. The u-piles end at station 0+240 (Photo 7) and the breakwater continues south as a concrete cap with timber cribs beneath (Photo 8). The steel sheet piles do not continue south across the end of the pier. There is a visible void behind the sheet piles that can be seen looking in from the end towards the south.

Photo 7 - South End of Pier East Sheetpiles

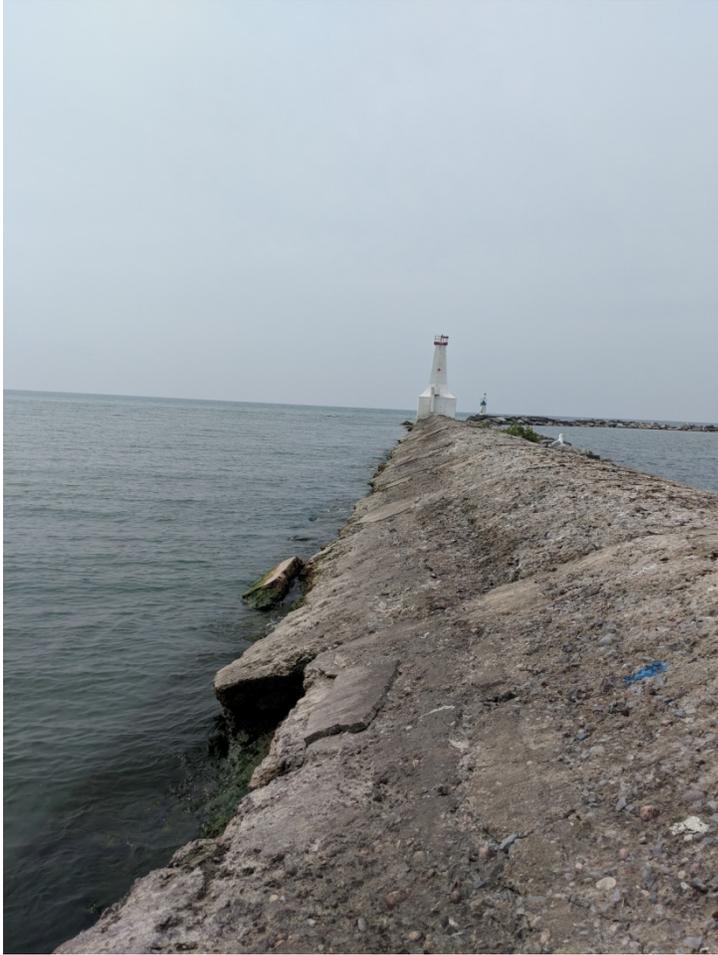
Photo 8 - Concrete Cap Breakwater

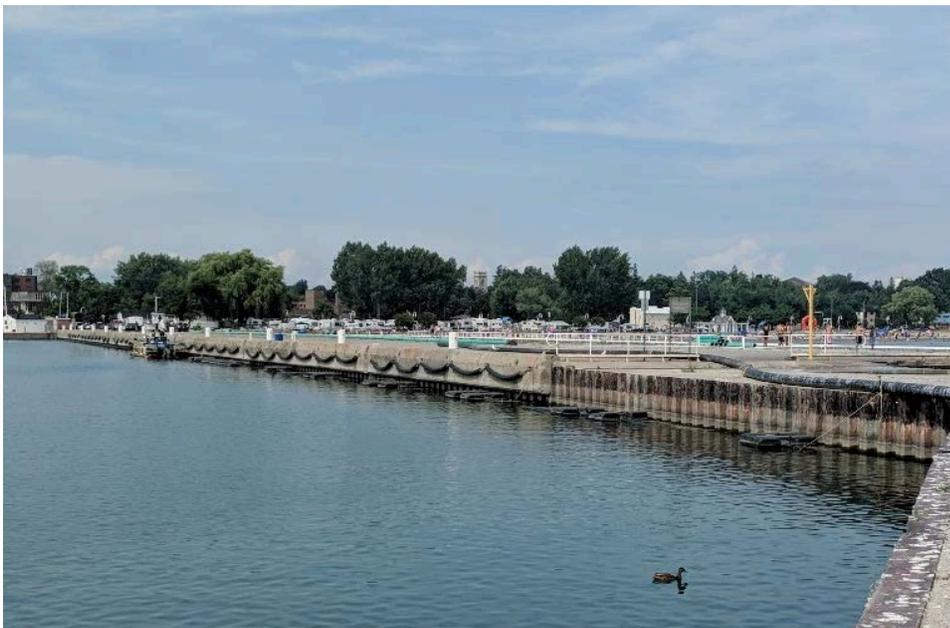
At the south end of the west wall there is no concrete cap, similar to the east side. A concrete cap on top of the steel sheet pile wall starts at station 0+315 and is much thicker on the west wall measuring over 1.0m thick (Photo 9). The water level was measured at 38cm below the bottom of the cap. Wall brackets were observed by the divers along this face near the lakebed. It is likely that these brackets correspond to locations of toe pins.

Photo 9 - West Side Wall

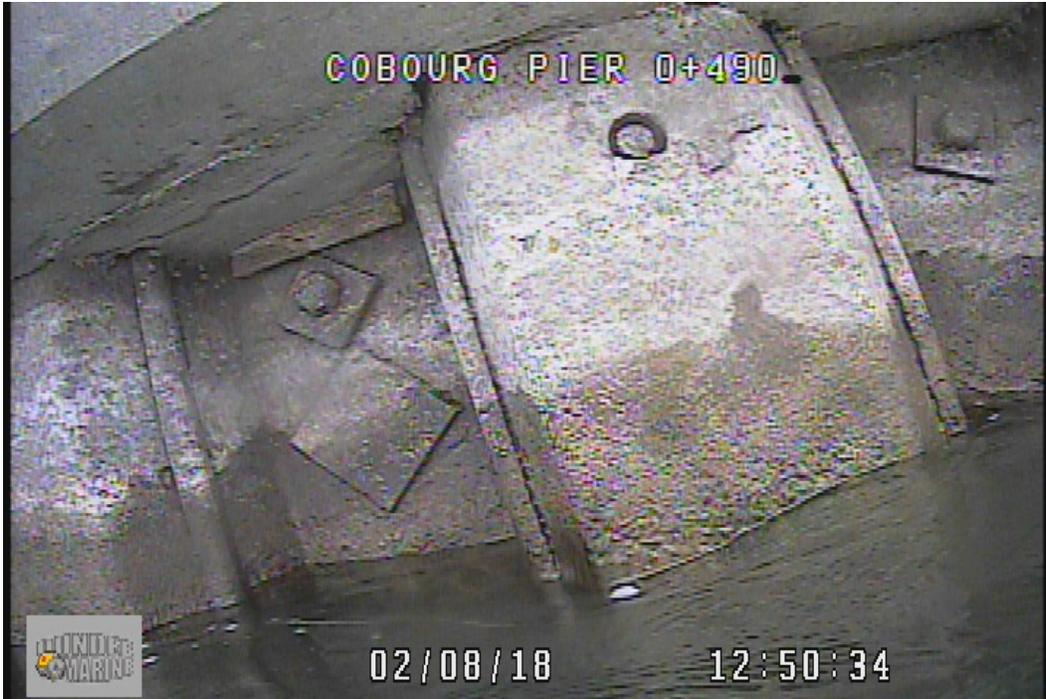
Photo 10 - Small Patches West Wall

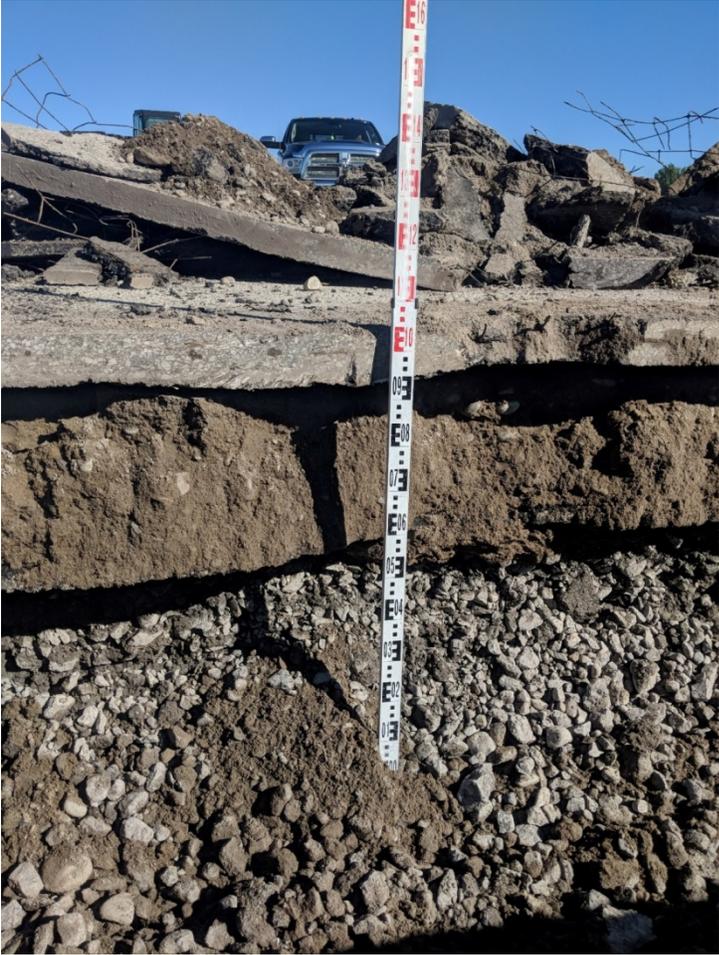
Two layers of asphalt were found, one approximately 0.5m above the other, with sand in between (Photo 12). The top layer is a double lift of asphalt measuring approximately 100mm in thickness while the lower layer is a single lift and thus approximately half the thickness at 50mm. The top layer of asphalt has a wire mesh in the top lift. The sand between the layers appears to have not been compacted as it was loose and easily removed.

Photo 12 - Double Layer of Asphalt

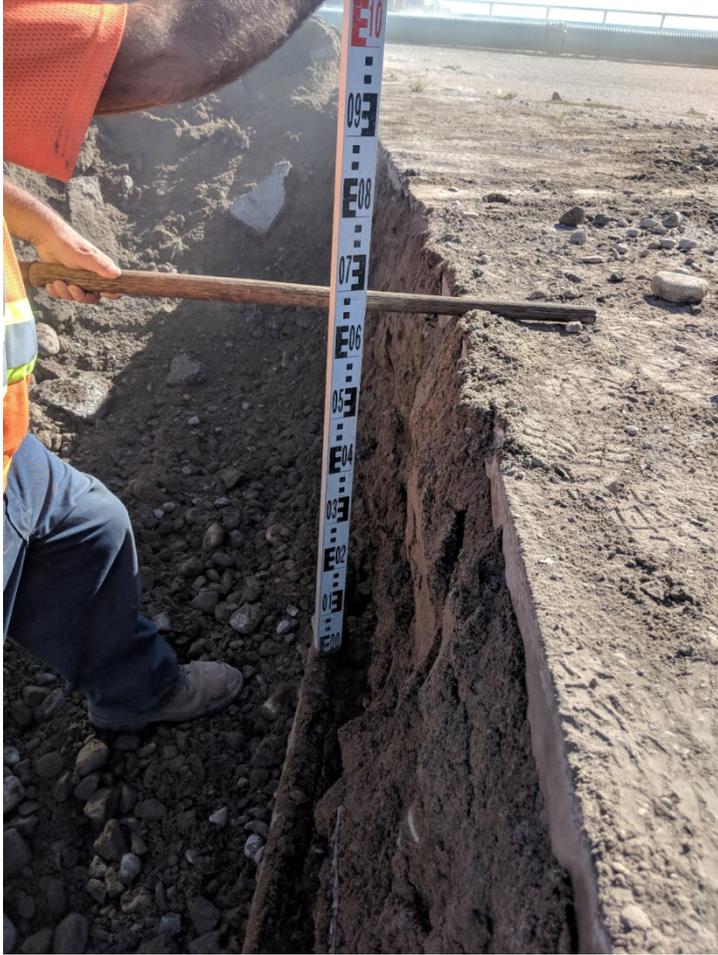
A tie rod was found running east west 0.65m below the surface and just below the second lift of asphalt (Photo 13). The tie rod dips down slightly as it progresses from west to east. A turn-buckle in the tie rod was found at approximately mid span. The ties rod did not run parallel with the trench and the ends were not located along the wall, however the elevation did match the tie bolts seen from the waterside of the wall.

Photo 13 - South Trench Tie

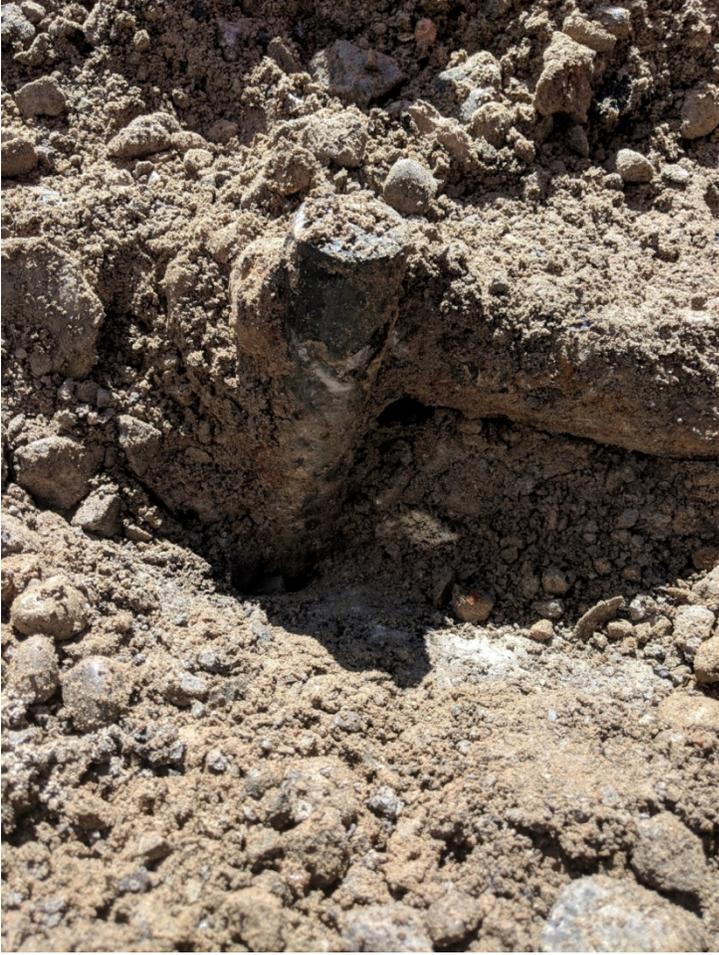
Just east of the centreline of the pier a concrete block was found approximately 4m wide buried 0.6m below the surface. The north edge of the block was visible, however, the south edge extended beyond the south side of the trench. The length of the block could not be determined. The trench was dug approximately 1.5m down from deck level and the bottom edge of the concrete block was not found. The tie rod runs on-top of centre block with a steel pin holding it in place (Photo 14).

Photo 14 - Pin Holding Tie On Top of Concrete Block

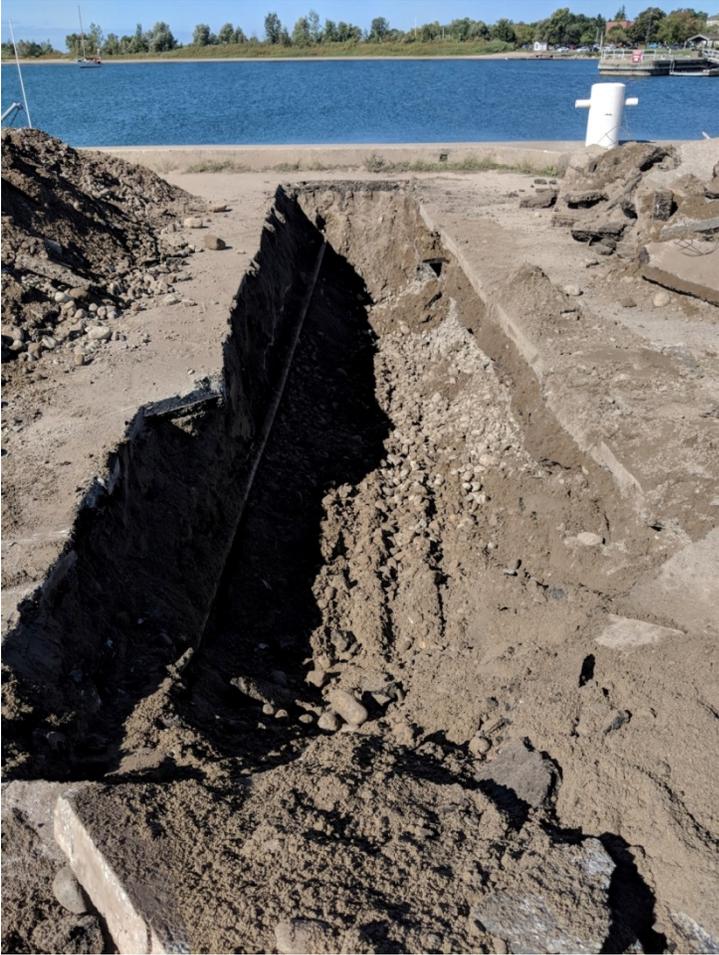
Fill material encountered in this trench below the lower layer of asphalt consisted mostly of sand with some larger boulders/stones in the centre third of the pier. The fill material in the outer thirds of the trench near the east and west walls was granular material similar to Granular A or B consistency (Photo 15).

Photo 15 - South Trench Looking West

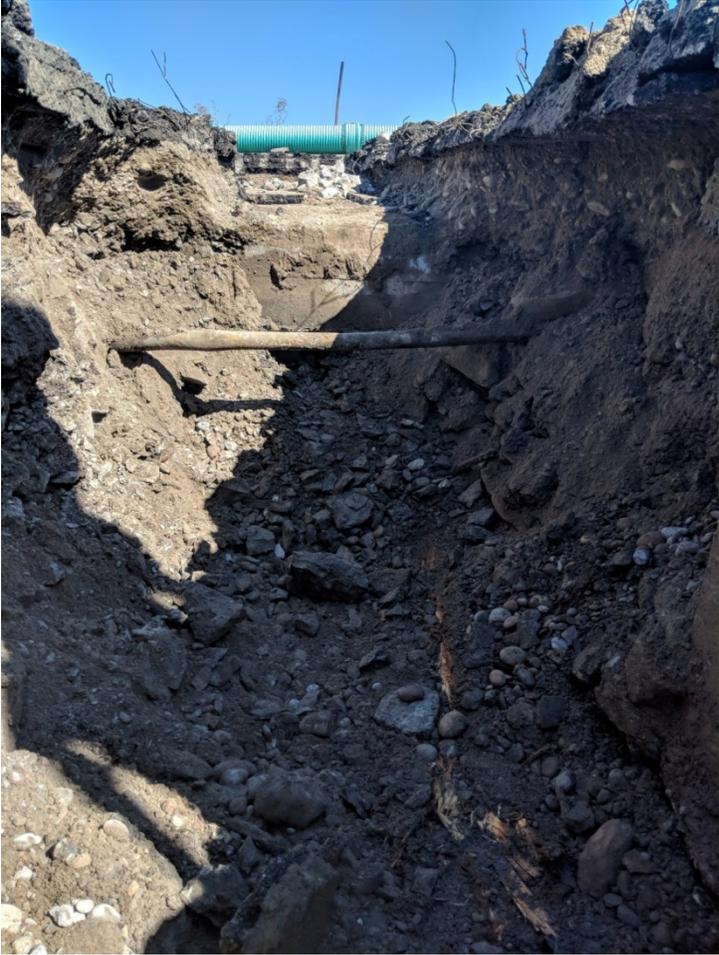
Steel pipes were found around mid-point of the pier running in a north south direction (Photo 16). The pipes were just below the second layer of asphalt. Another pipe was found near the east side concrete block. No fluid was observed in the pipes.

Pipes were found running down the centre of the pier. These pipes were heavily deteriorated. Fill material around these pipes was not compacted and of random consistency. It could be seen on the deck that the centre line of the pier had many location where repairs to sinkholes had been completed.

Photo 16 - Centreline Pipes

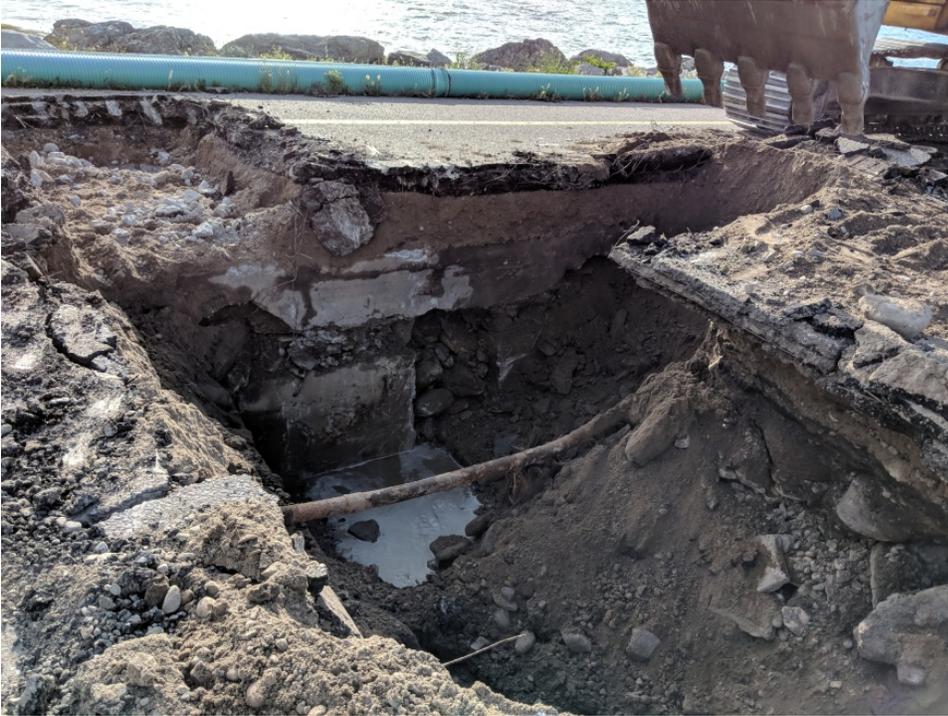
The east side of this trench had a concrete cap similar to the south and centre trenches. We were able to dig 2.2m down from top of deck (Photo 17). The east concrete cap was 1.6m thick and approximately 3m wide (east-west) extending from the top of the revetment westward. The top of the concrete block is approximately 0.6 m below the pier surface just below the lower asphalt layer.

Photo 17 - North Trench Looking East

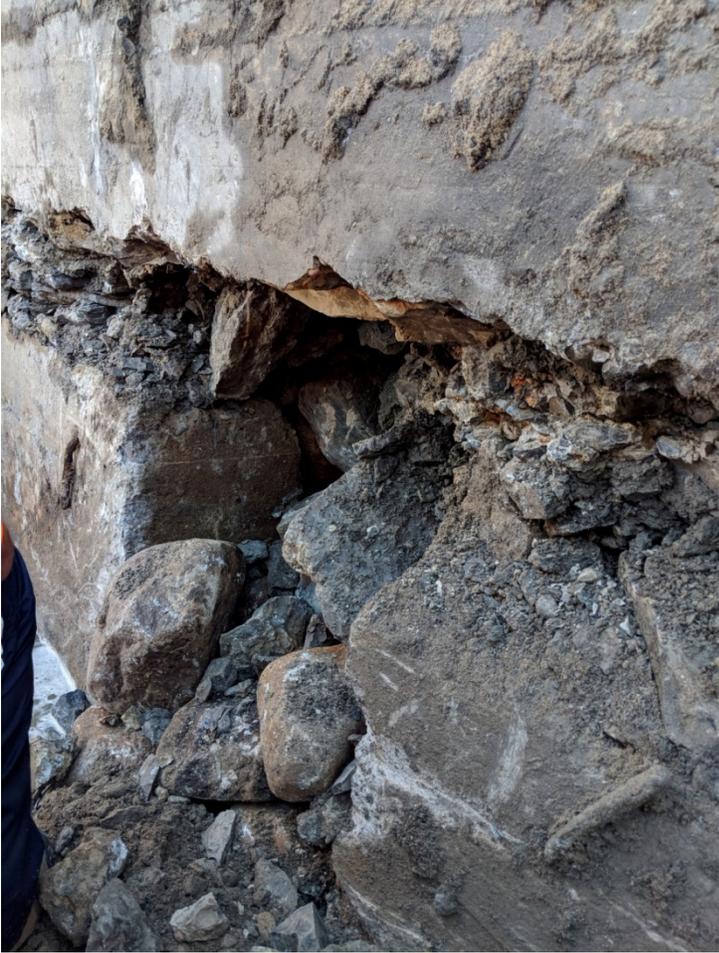
Fill material at this location both below and above the lower asphalt layer, is mostly un-compacted sand. At deeper elevations larger stones and rubble material was found. Sand was not found between the large stones that were placed adjacent to the east concrete cap at deep elevations (Photo 18).

Photo 18 - North Trench Large Stone Fill Without Sand
