October 22, 2018

Re: Cobourg East Pier Investigation
Our File: 18-2775

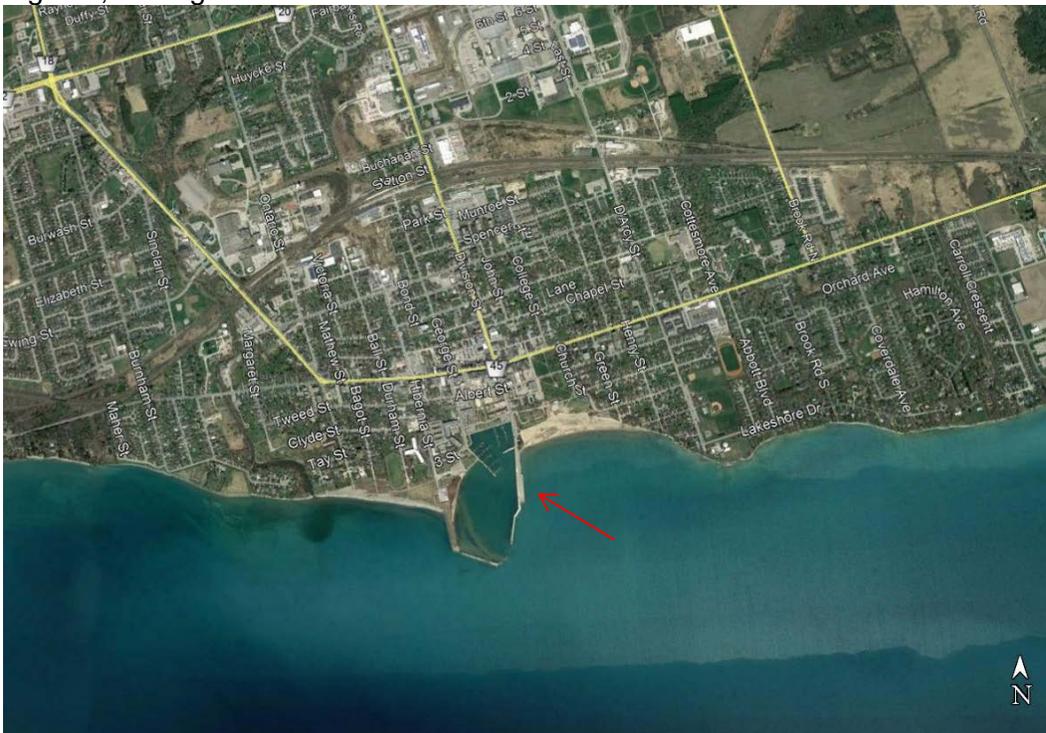
Figure 1 – Site Plan

Shoreplan Engineering Limited (Shoreplan) engineering was retained by the town of Cobourg to investigate the condition of the East Pier in Cobourg located between the Cobourg marina and the Cobourg Beach along the north shores of Lake Ontario. The pier is approximately 250m long. It is approximately 20m at the north end and 30m at the south end. The south part has steel sheet piles on the east and west sides while the north part has steel sheet piles on the west side and a stone revetment on the east side. The pier and the breakwater that extends from its south end of the pier protect the adjacent marina to the west from wave action. A plan of the pier area is provided on Figure 1.

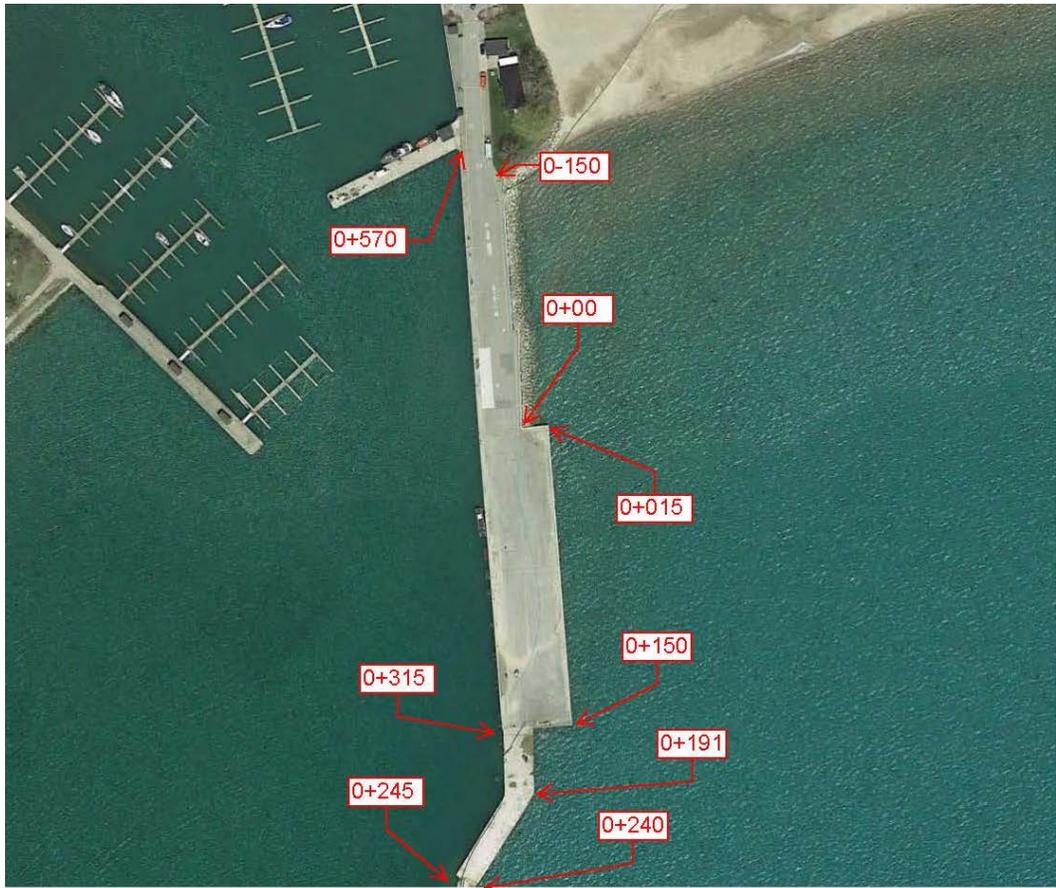
Figure 2 – Chainage

on the east side of the pier. This end was marked as station 0-105m. Station chainage is illustrated on Figure 2. Water level on the day of the dive was approximately 75.0 m IGLD85, as recorded at the water level gauge in Cobourg.

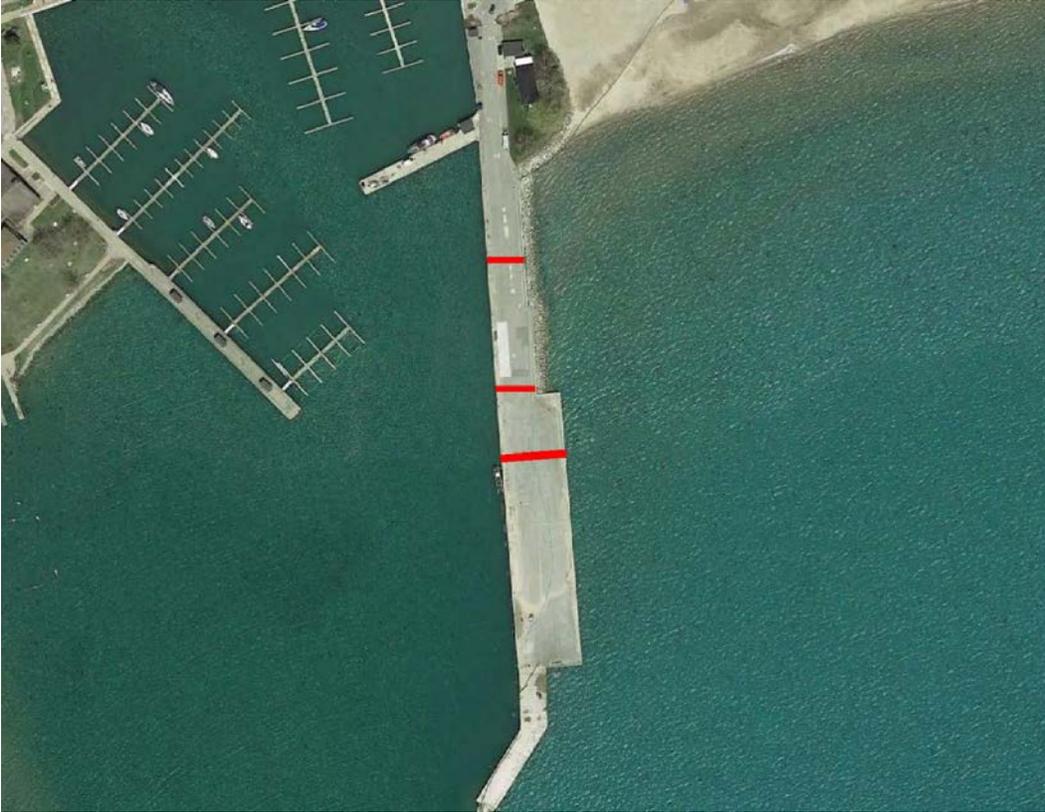
Figure 3 - Test Pit Locations

This trench is located approximately between chainage 0+040m and 0+440m on the south section and widest part of the pier. The location is indicated on Figure 3.

This trench is located approximately between chainages 0-002m and 0+449m on the north end of the pier. The location is indicated on Figure 3.

This trench is located approximately between chainage 0-063m and 0+510m, on the north end of the pier. The location is indicated on Figure 3.
